Sommarens Årets översvämningar

Faruk Djodjic, Institution för vatten och miljö, SLU

Water quality in a large complex catchment: Significant effects of land use and soil type but limited ability to detect trends

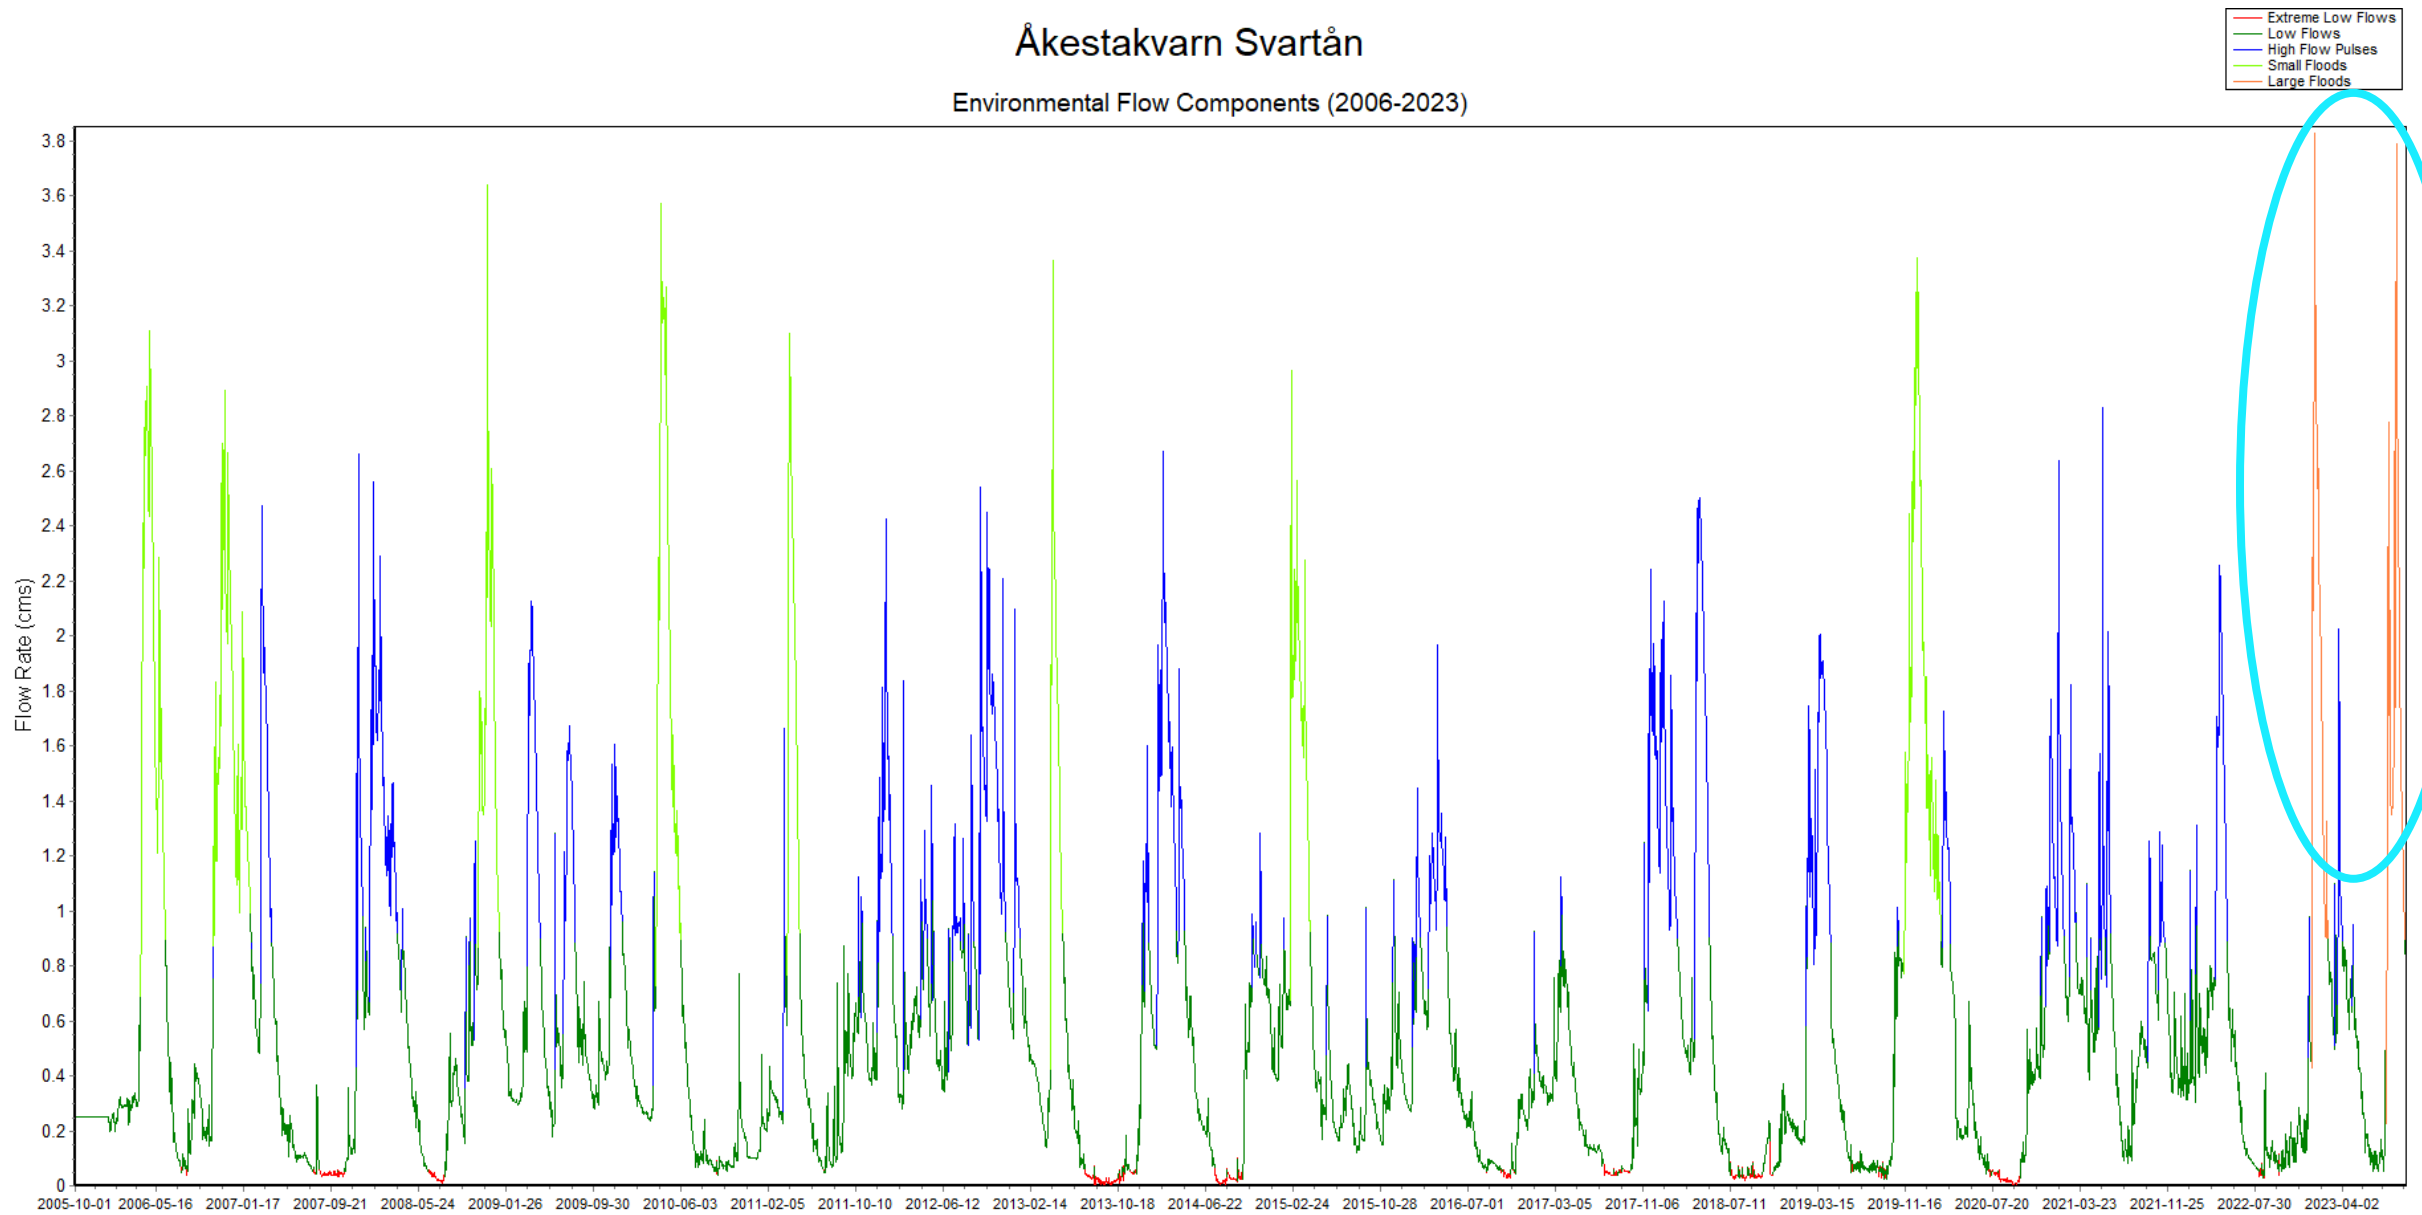
Åkestakvarn Svartån

Environmental Flow Components (2006-2023)
